**VOLUNTARY CLEANUP COMPLETION REPORT  
FOR THE  
SANTA CRUZ MINE AREA  
RICO, COLORADO**

### RECLAMATION MONITORING RESULTS FOR THE SANTA CRUZ MINE AREA

Photos Taken September 9, 1998

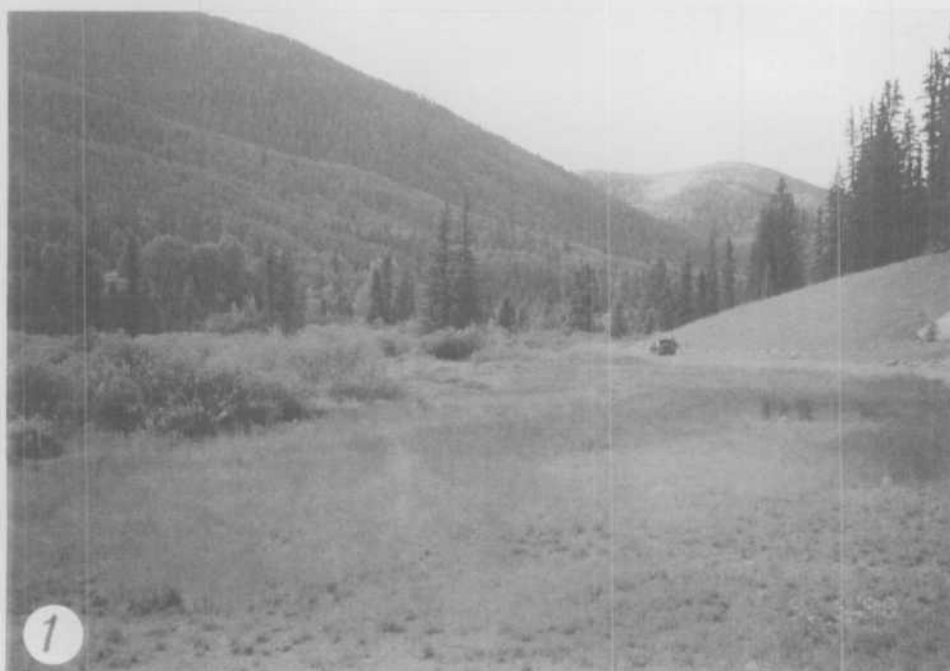
Photo #	Description
1	Near northern facility border looking south at wetland and revegetated waste rock slopes.
2	Near eastern facility border looking southwest at revegetated waste pile.
